Corrosion in the Petroleum Industry

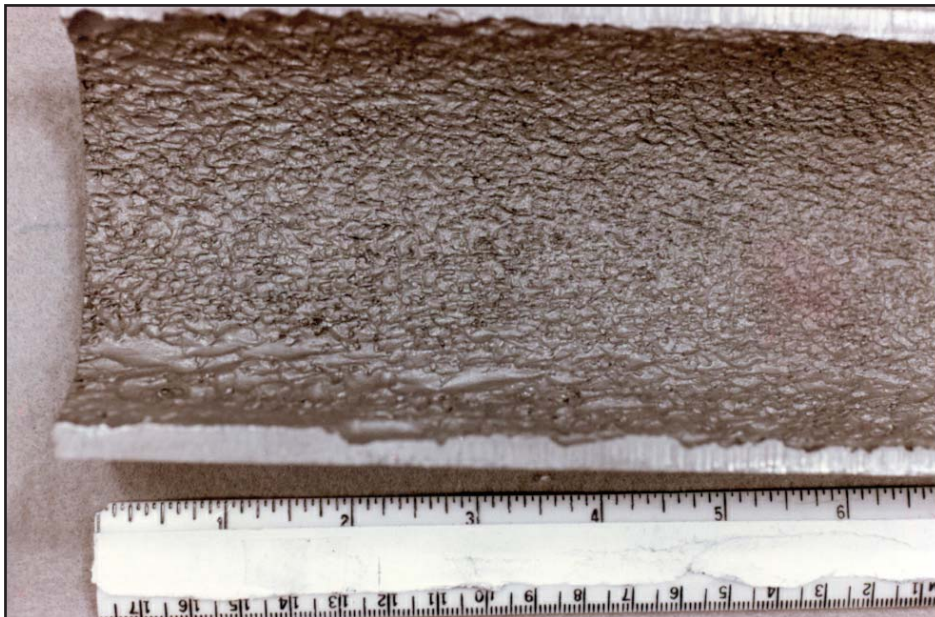
Figure I-4 and Figure I-5 show additional examples of uniform corrosion, leaving a distinctive hill and valley texture.

Figure I-4: Uniform Corrosion Showing Hills and Valleys

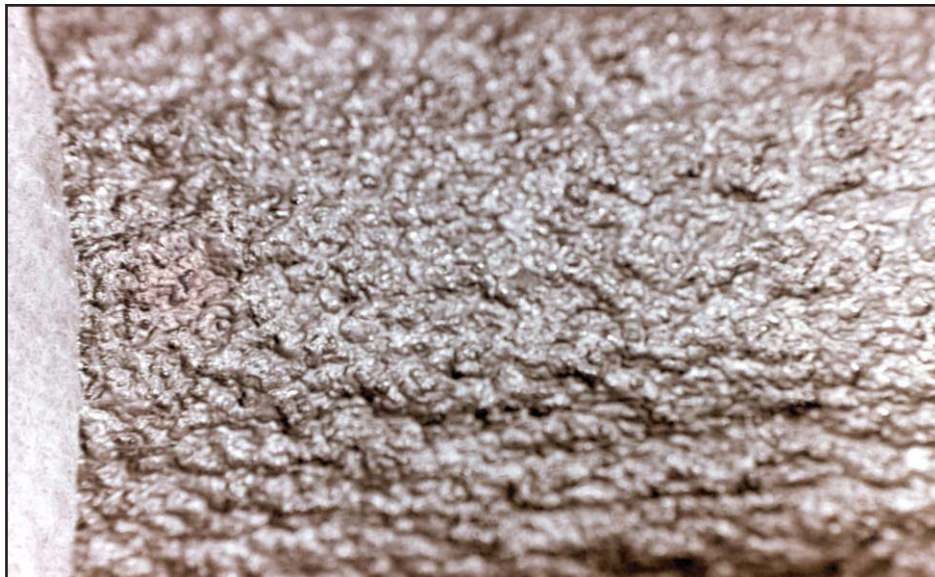
Figure I-5: Uniform Corrosion Showing Hills and Valleys

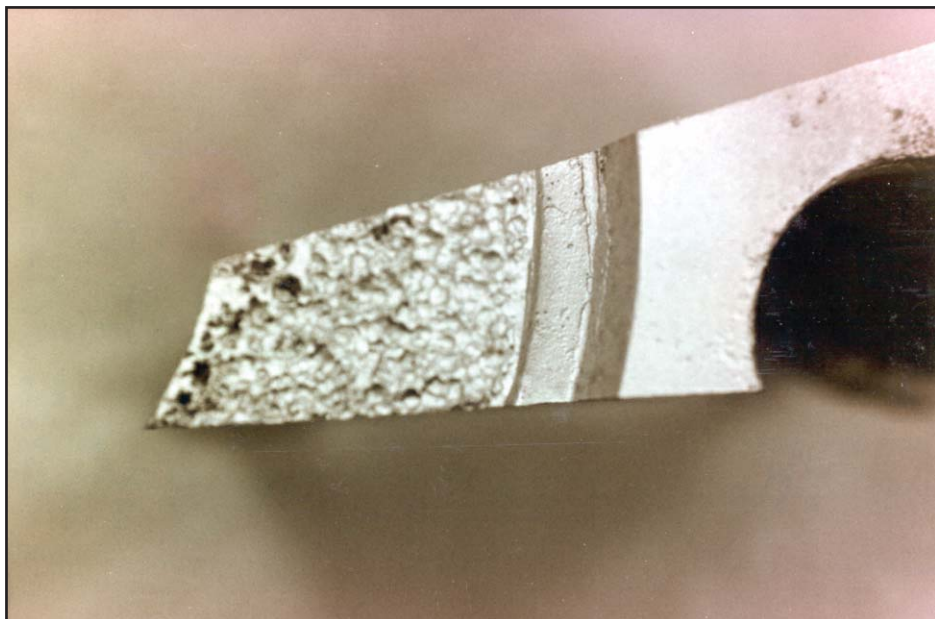
Another form of CO₂ attack has been observed on exposed faces of high-pressure wells, taking the form of an intricate honeycomb (Figure I-6 and Figure I-7).

Figure I-6: CO₂ Attack — Honeycomb Pattern

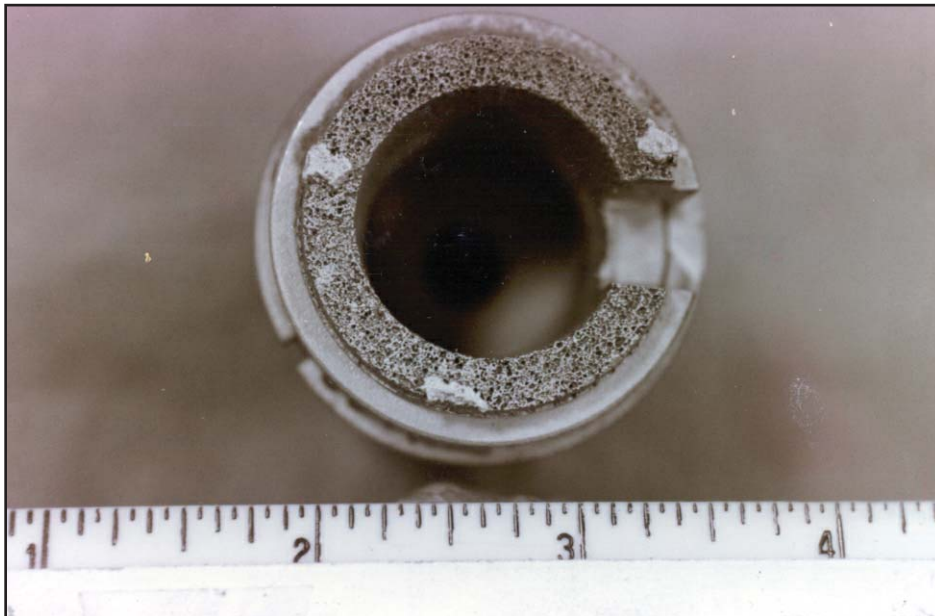
Another example of honeycomb attack can be seen on a choke body (Figure I-8).

Figure I-8: Honeycomb Attack in a Choke Body

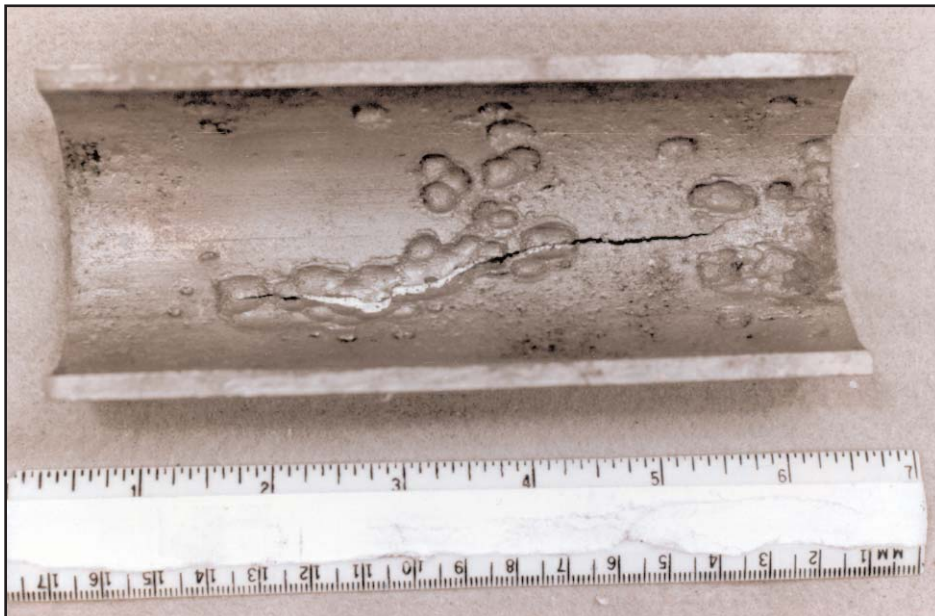
Another typical formation for CO₂ corrosion is called wormhole type of attack (Figure I-12).

Figure I-12: Wormhole Attack

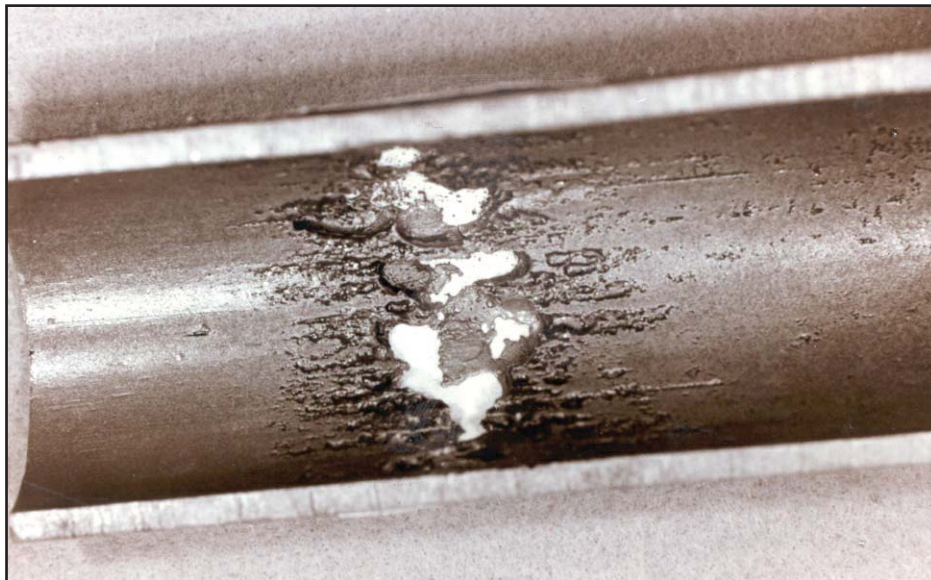
Ringworm corrosion is a metallurgical effect caused by the making of the upset. In fabricating the upset, a zone is created 4 to 6 inches from the upset shoulder, wherein carbon particles have been spheroidized. These spheroidal-shaped particles accelerate corrosion in mildly corrosive or even non-corrosive environments. This is a galvanic effect. If one observes numerous through-the-wall penetrations in tubing 4 to 6 inches from the upset shoulders such as in Figure I-18, ringworm corrosion is suspected.

Figure I-18: Suspected Ringworm Corrosion

The treatment for ringworm corrosion is to normalize the steel after making the upset. Normalizing redissolves the carbide particles eliminating the zone created by making the upset.

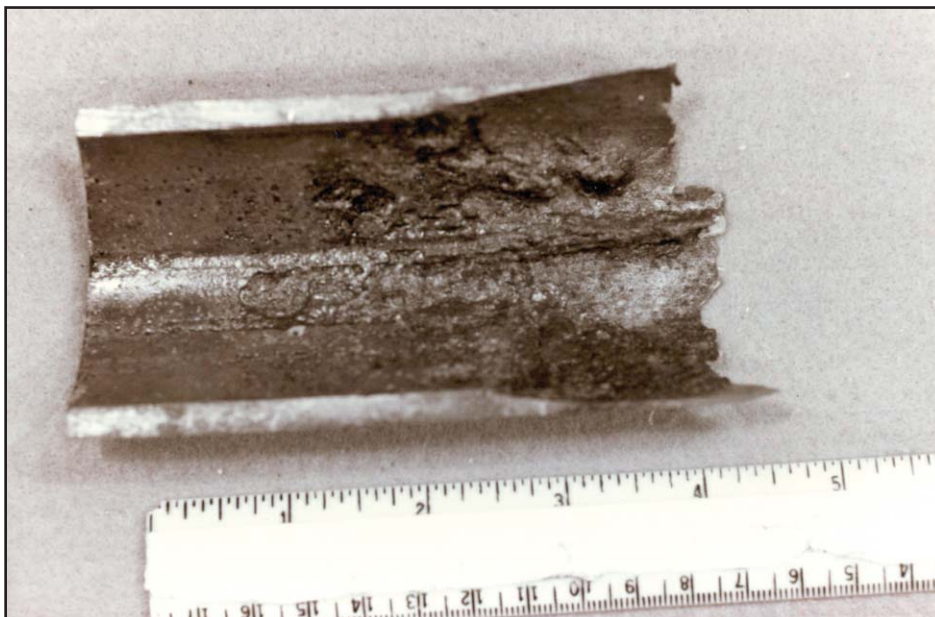
Another example shows severe thinning at this point, with a smooth surface (Figure I-20).

Figure I-20: Severe Thinning Caused by Ringworm Attack

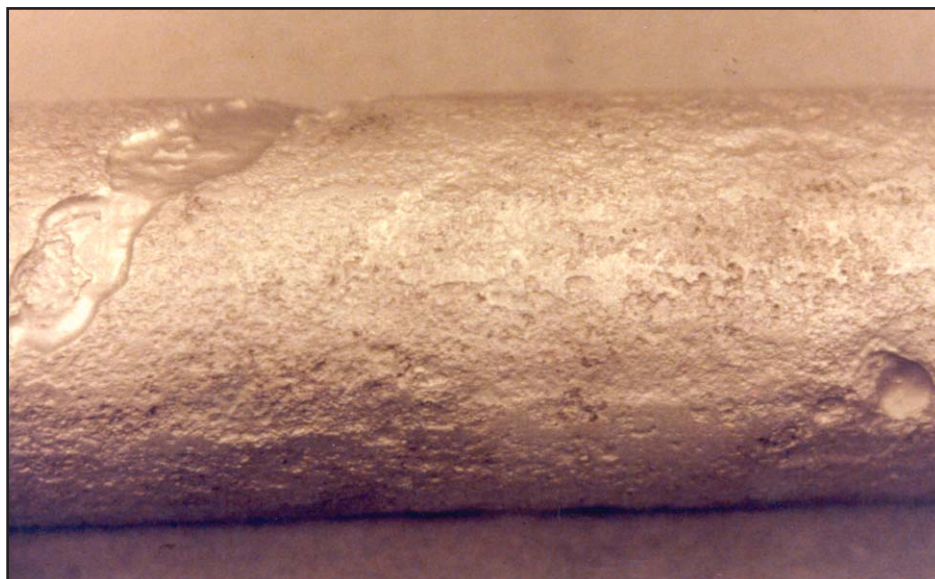
An unusual form of metallurgical attack on the outside of tubing is shown in Figure I-26 and I-27, and is attributed to rolled-in inclusions.

Figure I-27: Corrosion Resulting from Rolled-in Inclusions

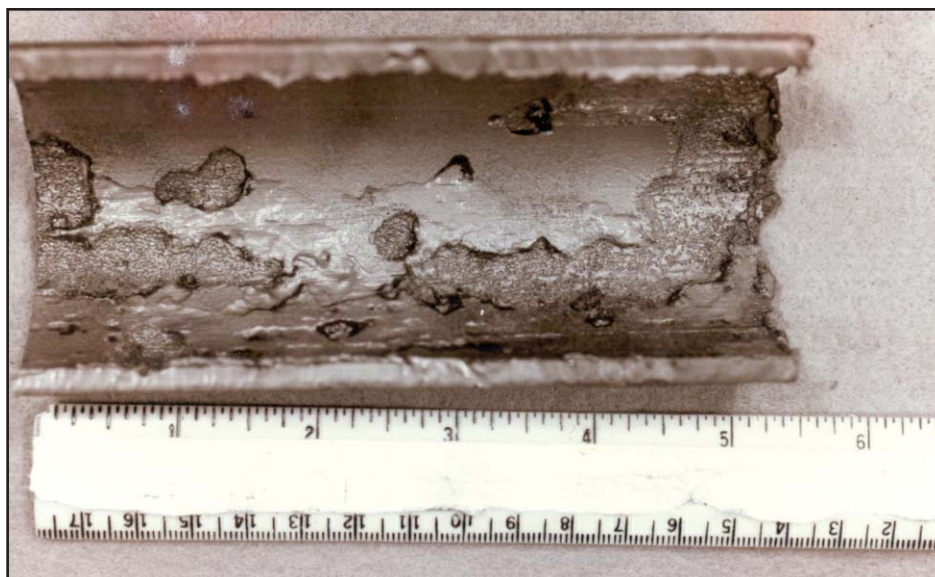
Another form of CO_2 corrosion is called mesa attack. Mesa attack usually occurs where areas of metal that have a good protective coating exist and where other areas have no protective coating. In addition, mesa attack occurs in flowing environments (Figure I-28).

Figure I-28: Mesa Attack

Tubing that has undergone mesa attack can be seen in Figure I-29. Flat surfaces and deep gouges between the flat surfaces typify it (Figure I-30). Mesa corrosion can be controlled with inhibitor films to get greater protection on those surfaces where corrosion has occurred.

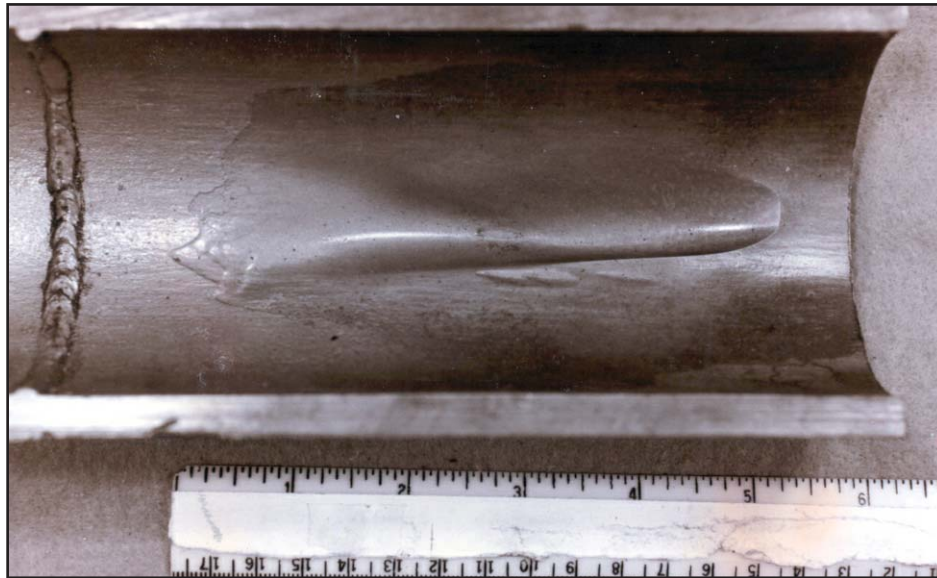
Another form of severe metal loss usually leading to rapid failures is flow-enhanced corrosion (Figure I-37).

Figure I-37: Flow-Enhanced Corrosion

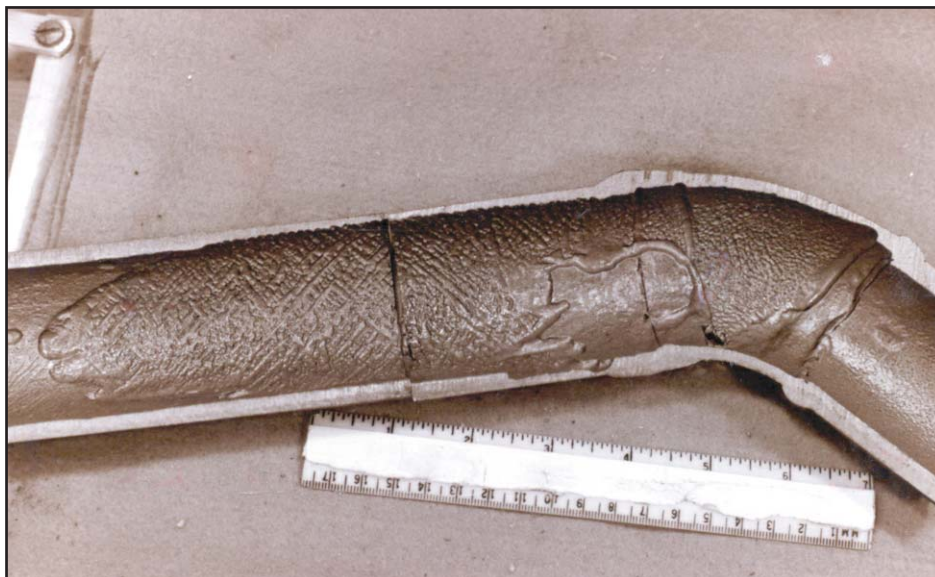
After a 45° bend, severe metal loss was noted in the bend (Figure I-42). In addition, a clear demarcation can be found where the flow had ceased, and there was no further attack on the pipe.

Figure I-42: Severe Metal Loss in Bend

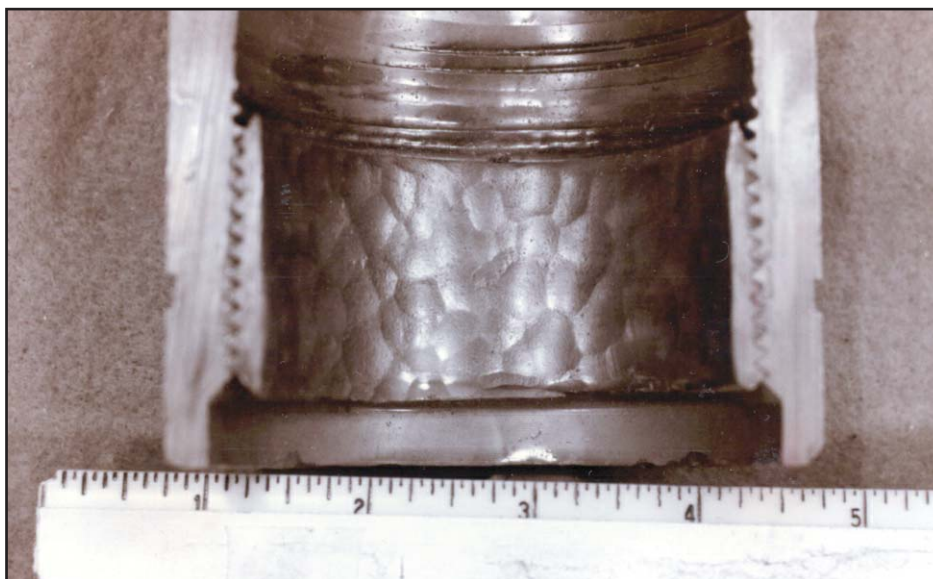
Sand erosion can also occur (Figure I-46). This erosion is typified by a smooth surface with a sand dune pattern.

Figure I-46: Sand Erosion

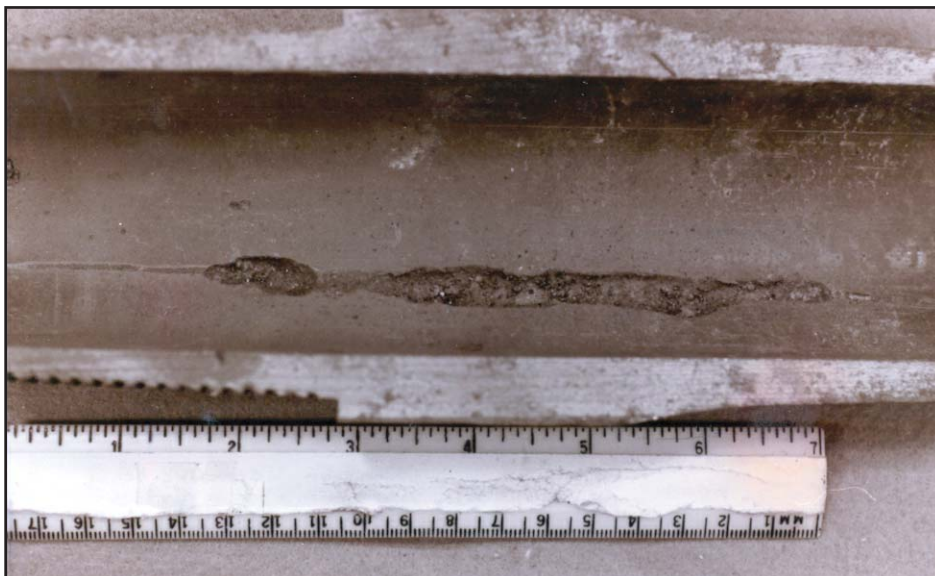
On coated tubing, wireline operations can sometimes cut the protective coating, resulting in corrosive attack where the breaks occur (Figure I-47 and Figure I-48). This attack is termed wireline attack.

Figure I-48: Wireline Attack

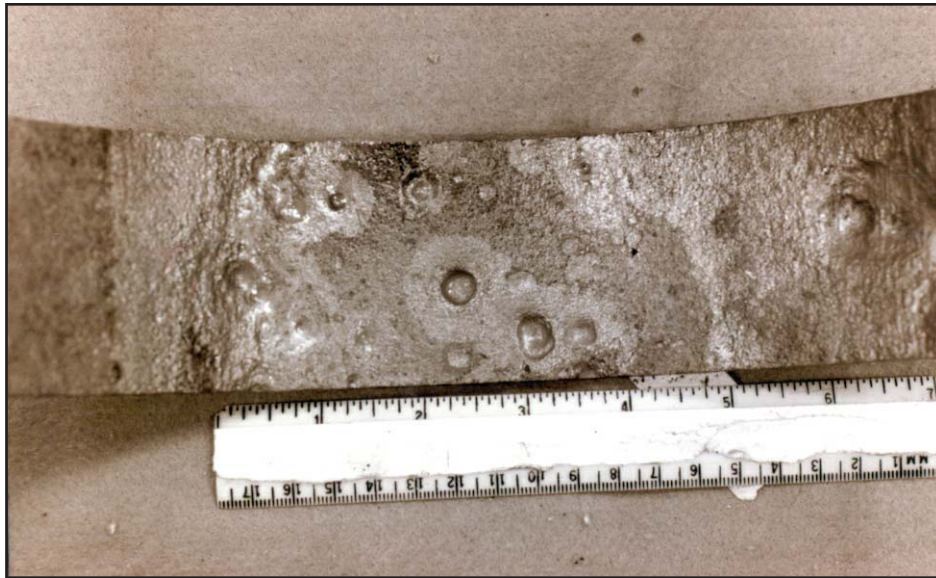
Oxygen is an extremely corrosive gas in produced brines, even more corrosive than CO_2 . Oxygen corrosion (Figure II-1) usually results in iron oxide corrosion by-products, usually hematite, goethite, and magnetite.

Figure II-1: Oxygen Corrosion

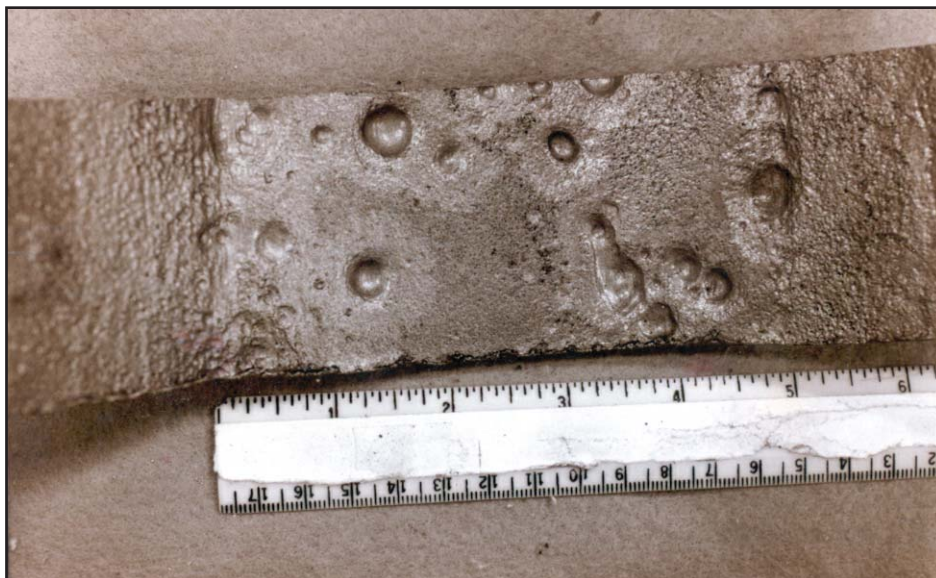
Typically, the corrosive by-products are a reddish brown rust (Figure II-2).

Figure II-2: Oxygen Corrosion in a Flowline

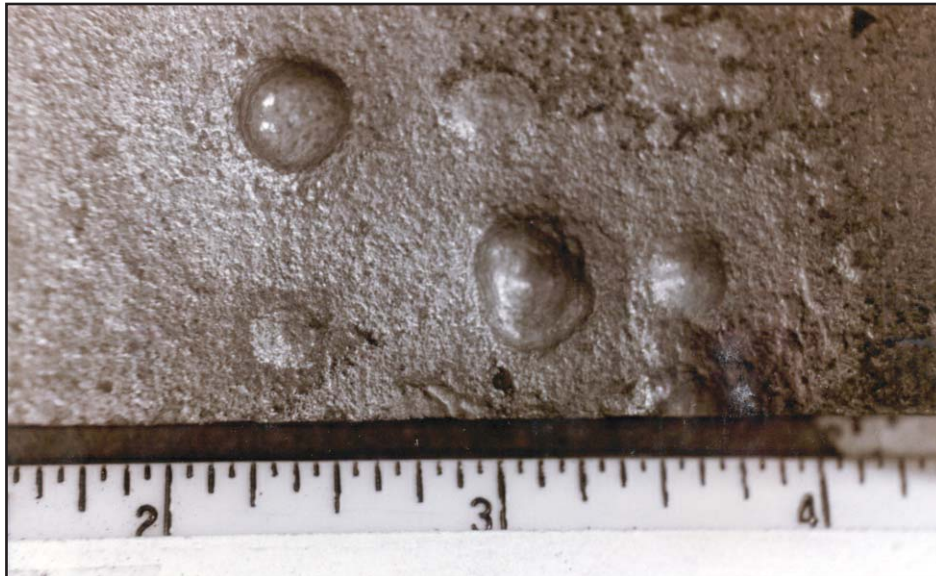
A close-up view shows the typical pits (Figure II-3).

Figure II-3: Typical Pits

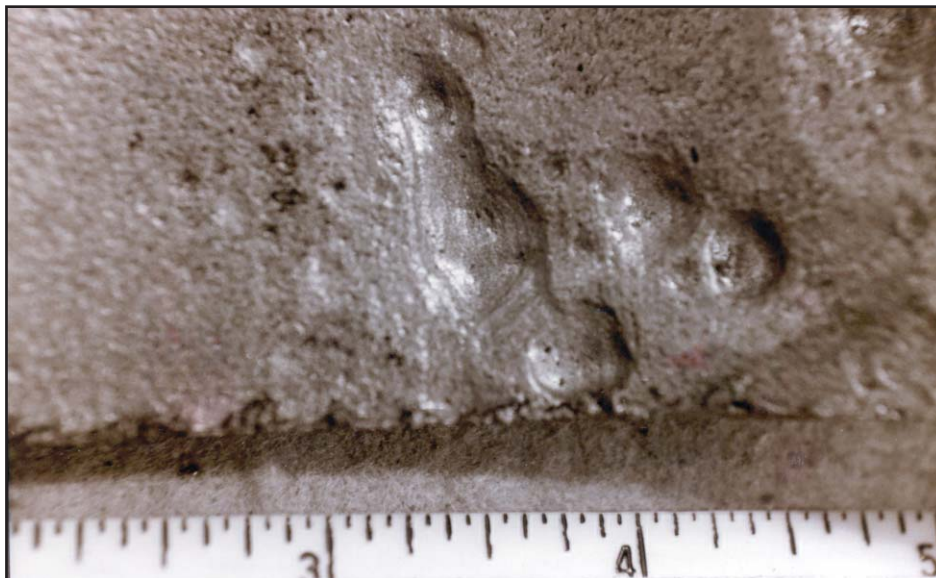
On cleaning, the shallow saucer-like pits are seen (Figure II-4).

Figure II-4: Shallow Saucer-like Pits

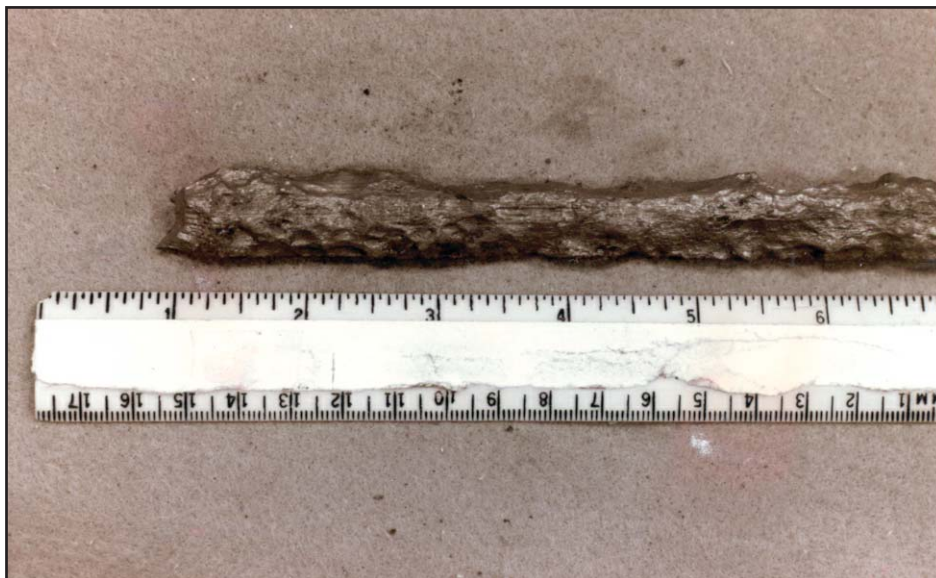
Oxygen corrosion on sucker rods are large areas of metal loss (Figure II-5 and Figure II-6).

Figure II-6: Areas of Metal Loss on Sucker Rods

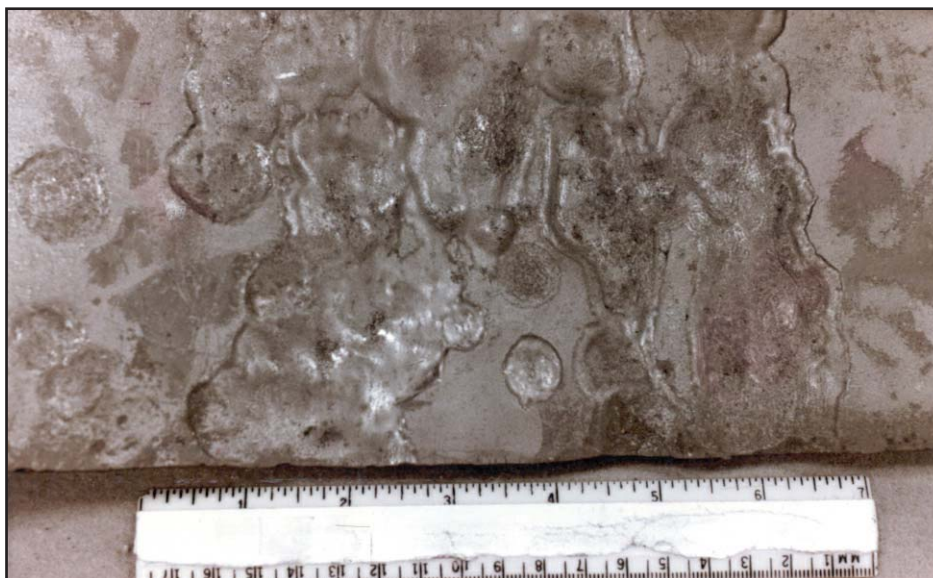
Another example of oxygen corrosion is in this 36" pipeline (Figure II-9).

Figure II-9: Oxygen Corrosion in a 36" Pipeline

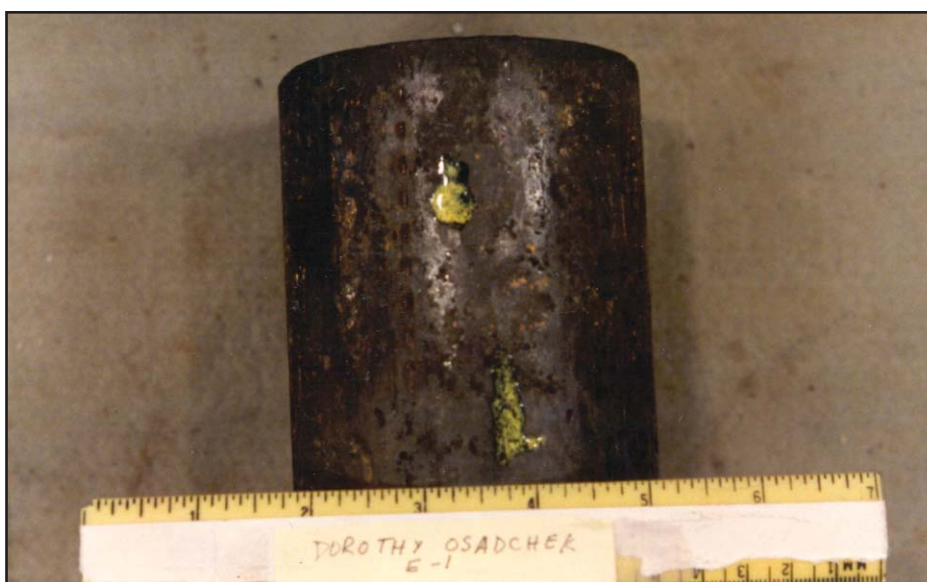
Some examples of the hydrogen sulfide attack are shown in Figure III-2.

Figure III-2: Example of H_2S Attack

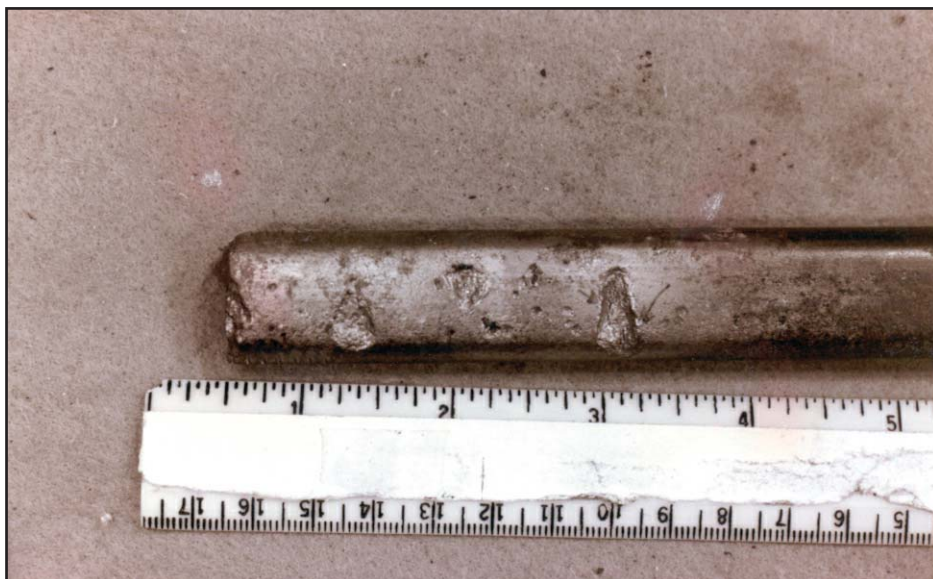
Figure III-5: H₂S Attack on Sucker Rods Followed by Corrosion Fatigue Break

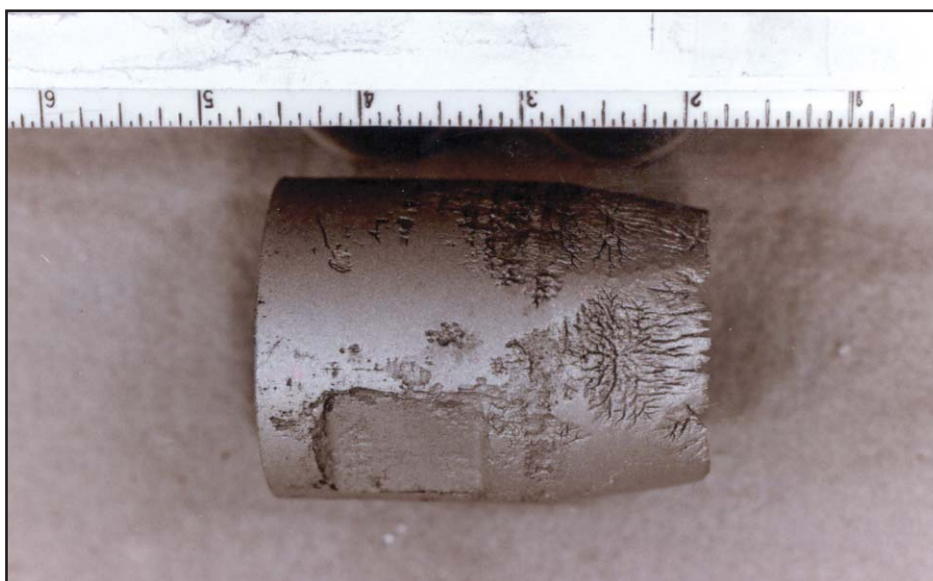
Alternating stresses can propagate notches, which are initiated by corrosion. An example of corrosion fatigue occurred in sucker rod connectors (Figure III-7).

Figure III-7: Corrosion Fatigue in Sucker Rod Connectors

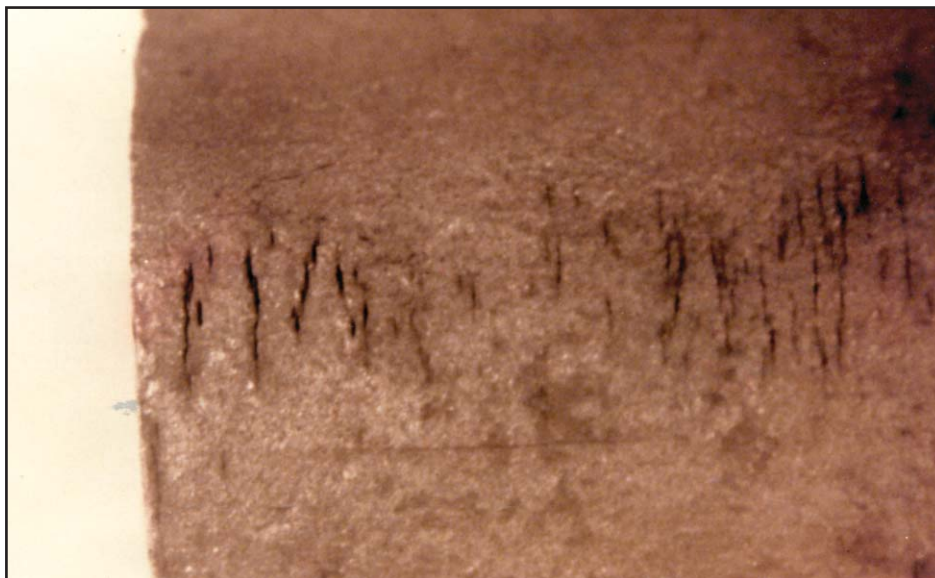
A cross-section shows how deep the cracking can propagate into the metal, with a very small opening (Figure III-8 and Figure III-9).

Figure III-8: Crack Propagation

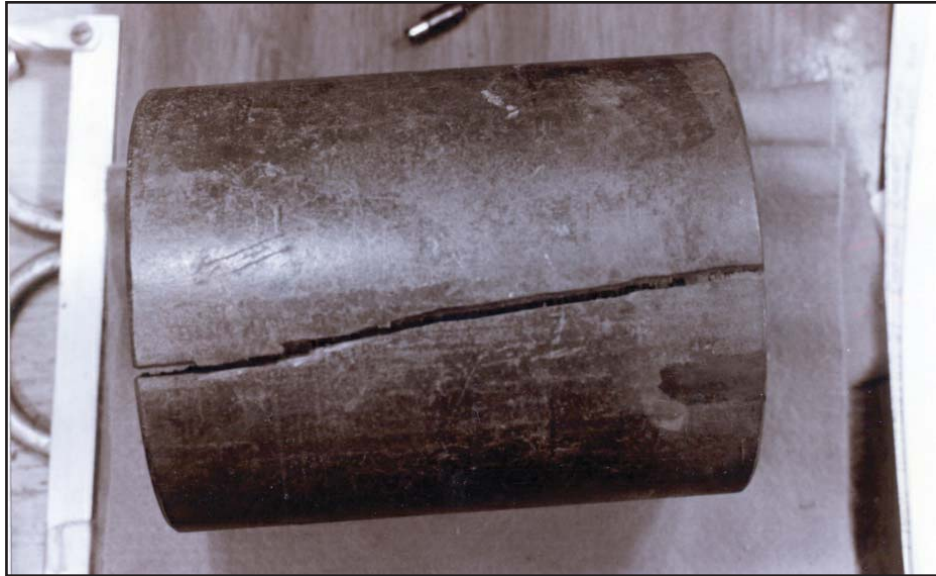
Drilling collars and the drilling operation are also subject to sulfide stress cracking. Drilling stresses can cause failures. Figure III-11 shows a failure of a casing collar attributed to H₂S stress cracking.

Figure III-11: Sulfide Stress Cracking of a Casing Collar

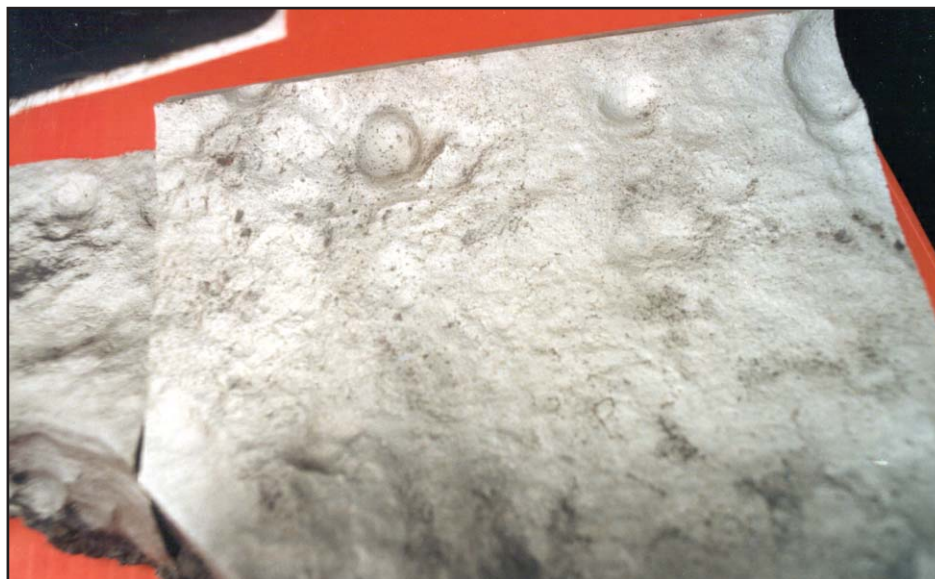
Closer inspection of the pits shows smooth depressions with gently sloping sidewalls and smooth bottoms (Figure V-2).

Figure V-2: Closer Inspection of the Pits

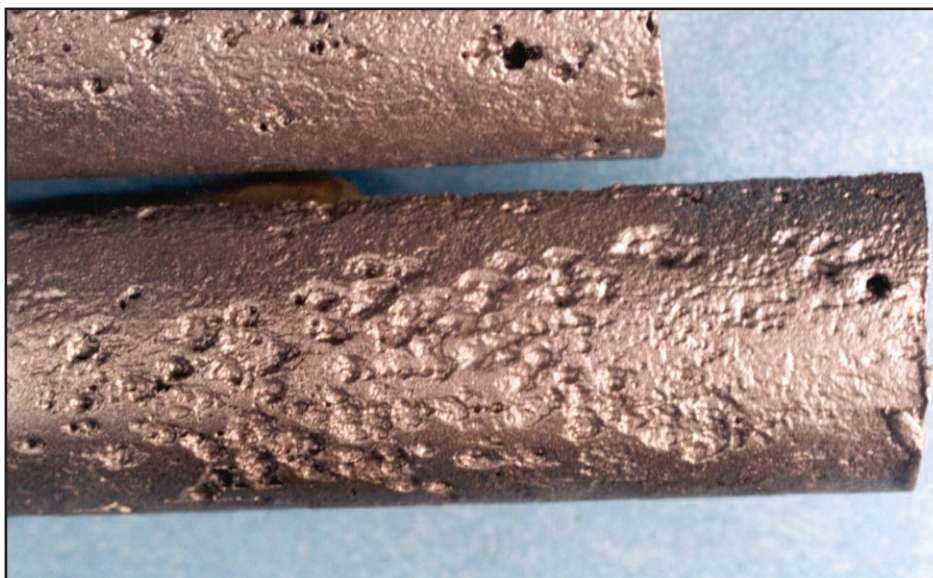
The pits with narrow openings and deep cavernous voids are typical of hydrochloric acid pitting (Figure V-6).

Figure V-6: Pits with Narrow Openings and Deep Cavernous Voids

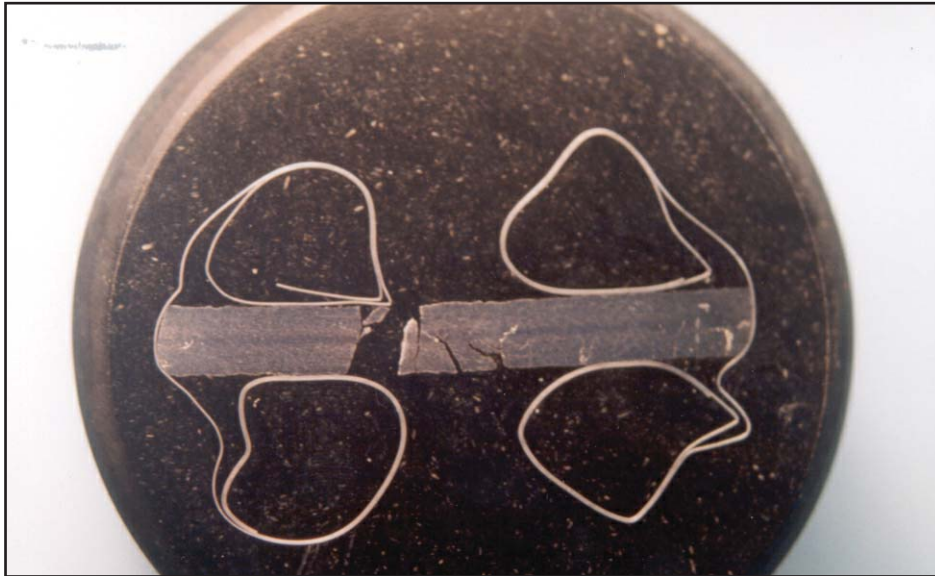
304L Stainless steel tray-stressed corrosion cracking failure. Corrosion was pitting attack attributed to hydrogen sulfides or chlorides.

Figure V-9: 304L Stainless Steel Tray

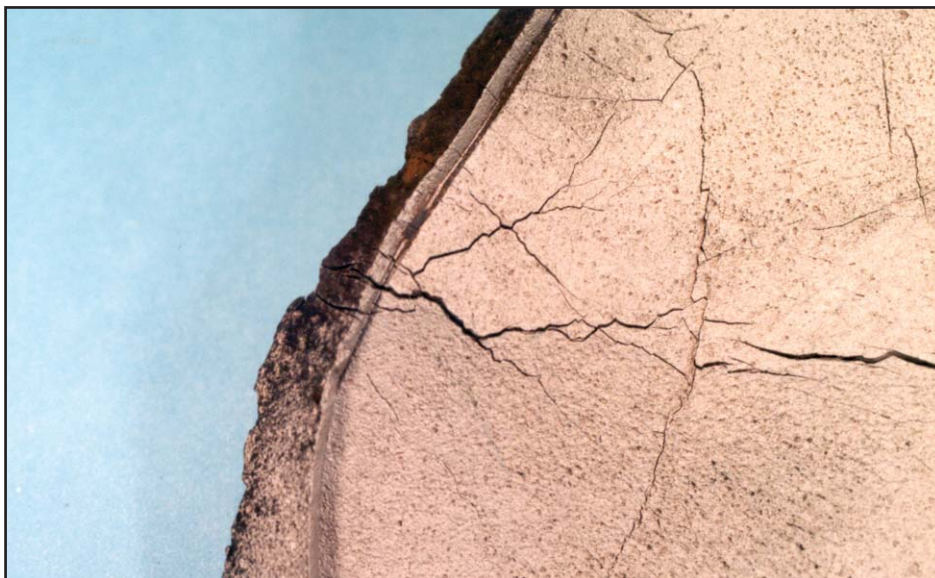
Figure V-10: Stress Corrosion Cracking Failure

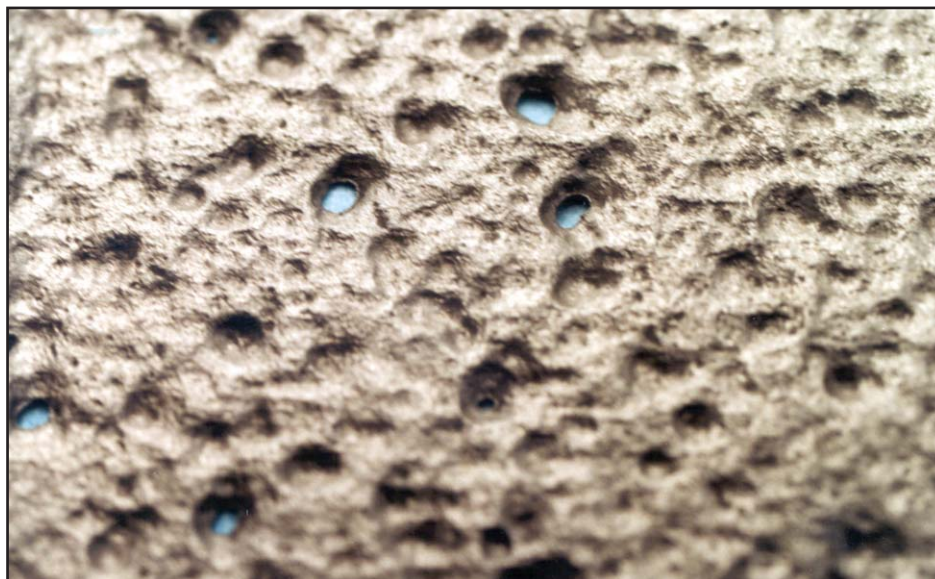
Figure VI-1 shows an example of Naphthenic Acid attack on a 14Cr Tray.

Figure VI-1: Naphthenic Acid attack on 14Cr Tray

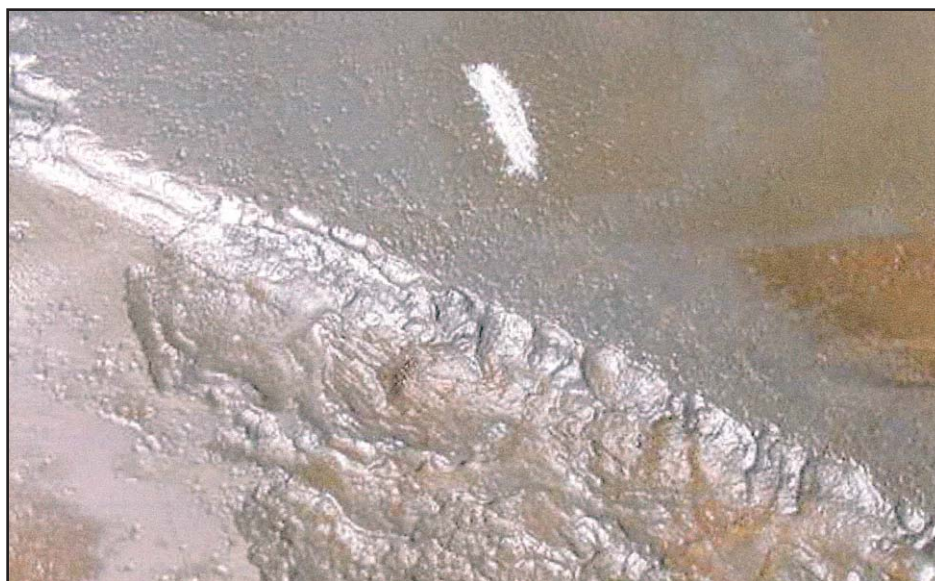
Figure VIII-13: Close-up View of the Corrosion at a Plate Boundary

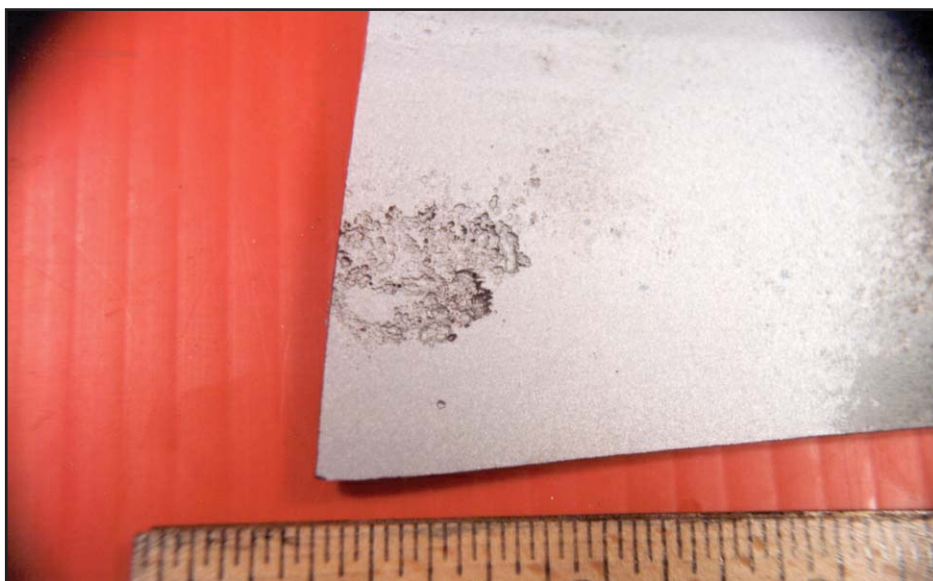
Figure VIII-16: Fuel Storage Tank Corrosion

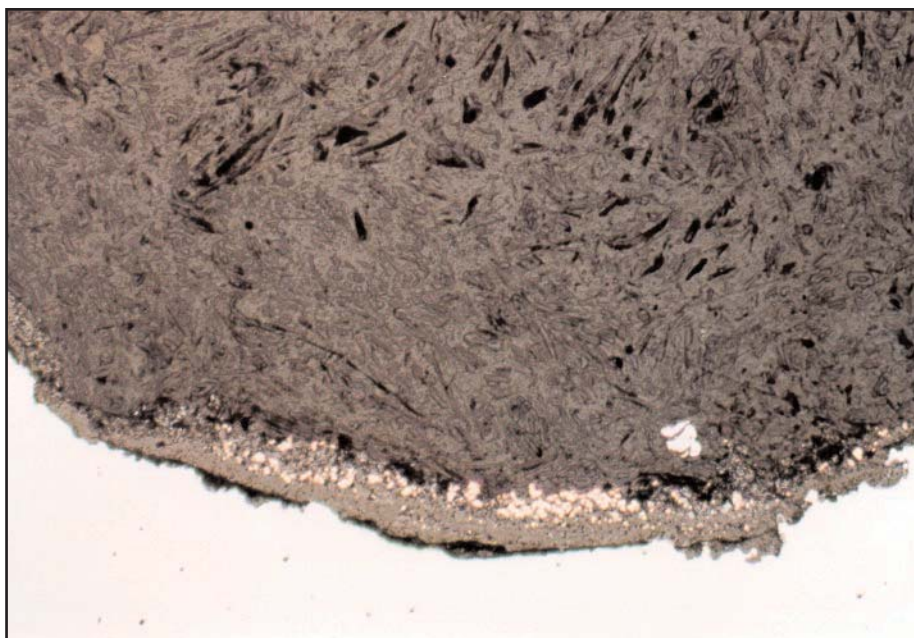
Alkaline deposits, containing sodium, covered the surface in the corroded area (Figure IX-4). Metallographic analysis revealed the presence of magnetite needles and metallic copper on the corroded surface.

Figure IX-4: Corrosion Products in Wasted Area Containing Magnetite Needles and Metallic Copper Particles

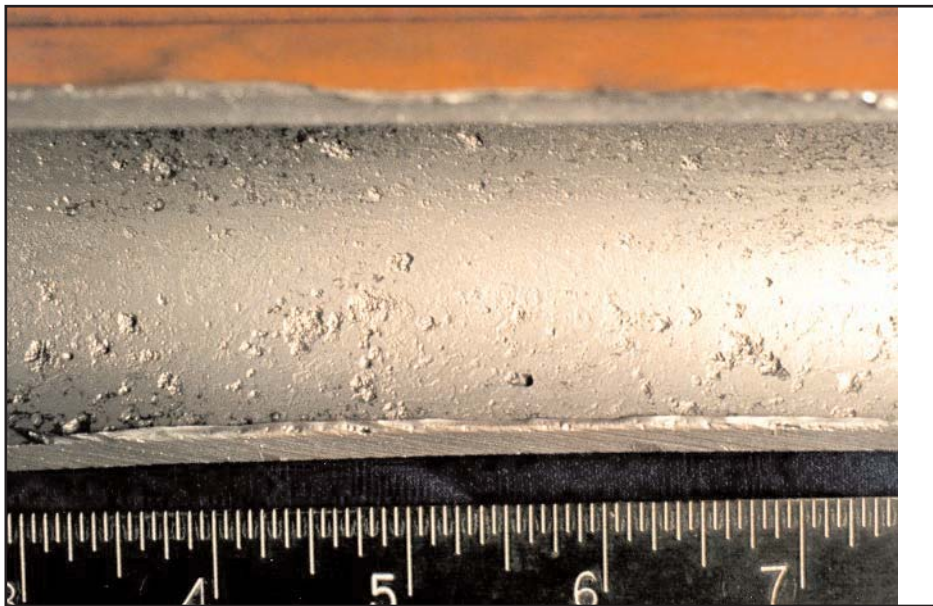
Figure IX-7: Depressions Formed at Tubercle Sites Revealed by Cleaning

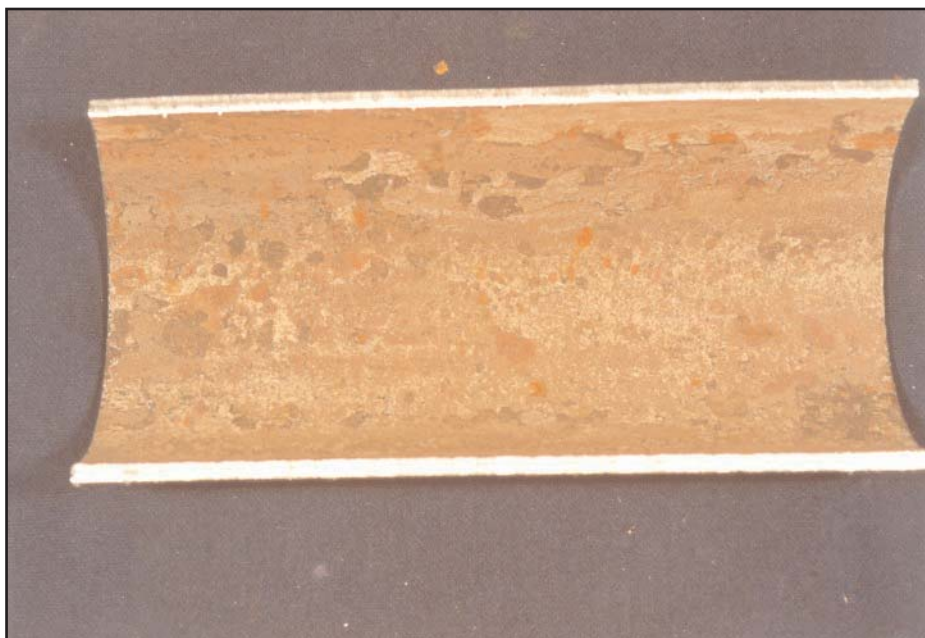
Multiple leaks occurred in tubes located near the received section of tubing. Regions containing families of moderately deep fissures were present on the hot side internal surface beneath thick deposit layers (Figures IX-9 and Figure IX-10). The fissures propagated transgranularly through the microstructure and were filled with dense oxide containing a centerline crack (Figure IX-11). These features indicated the fissures were caused by corrosion fatigue cracking.

Figure IX-9: Heavy Deposit Layers Covering Internal Surface of Boiler Tube

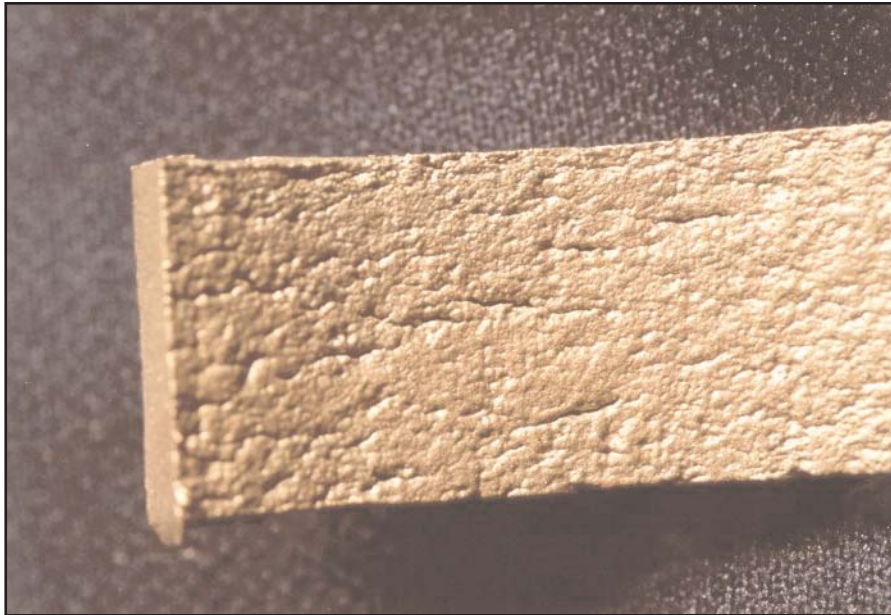
Figure IX-10: Numerous Transversely Oriented Fissures on Internal Surface

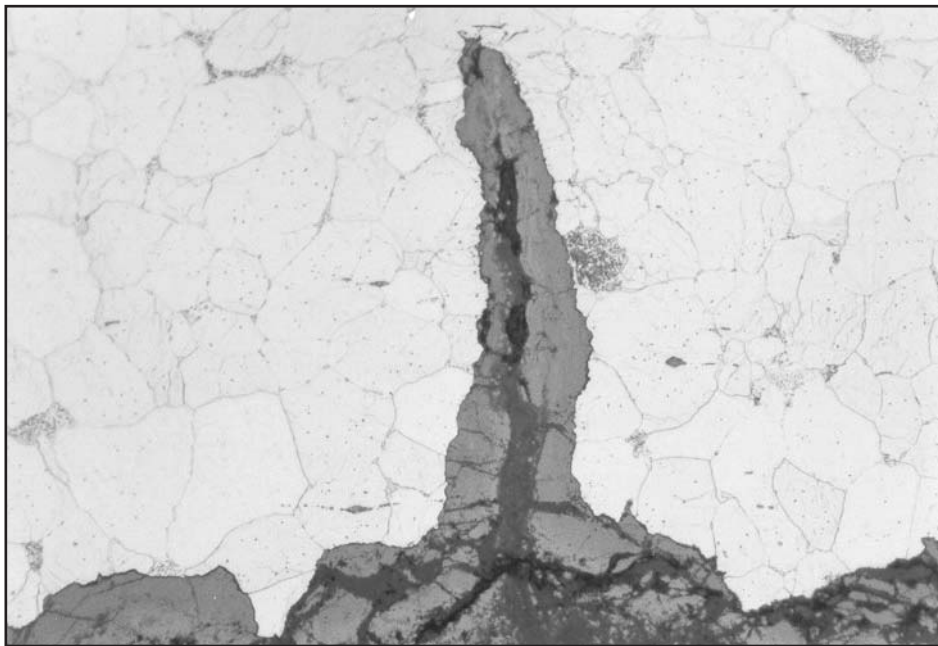
Figure IX-11: Fissure Caused by Corrosion Fatigue Cracking Filled with Dense Oxide Containing Centerline Crack

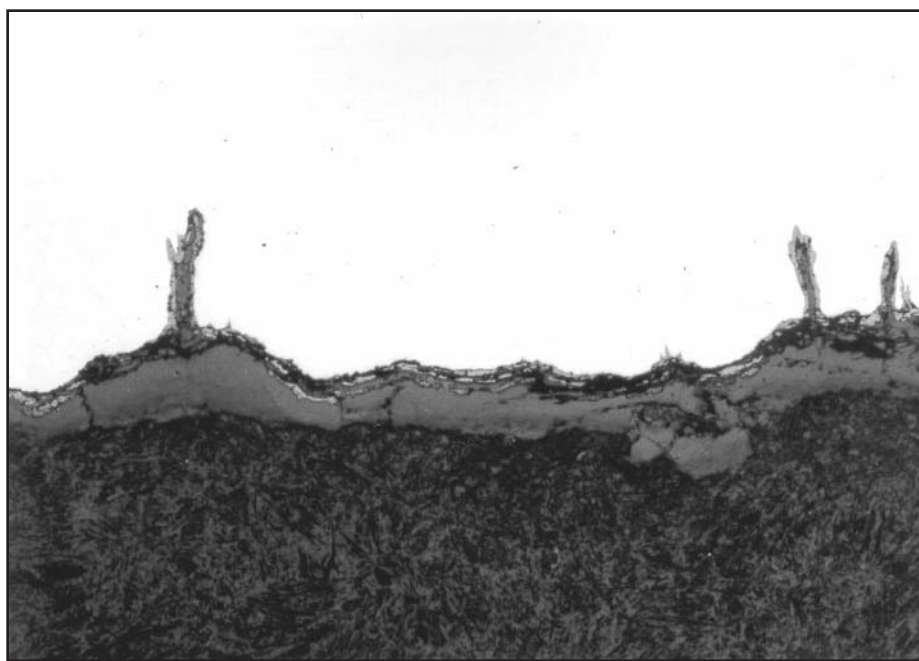
Stresses may concentrate at locations of physical constraint and surface discontinuities, such as depressions and notches. The fissures were localized to shallow depressions caused by old oxygen corrosion that occurred during boiler idle time (Figure IX-13). These shallow depressions acted as stress concentrators, promoting nucleation sites for fissures.

Figure IX-13: Numerous Fissures Initiating from Shallow Depressions Caused by Old Idle Time Oxygen Corrosion

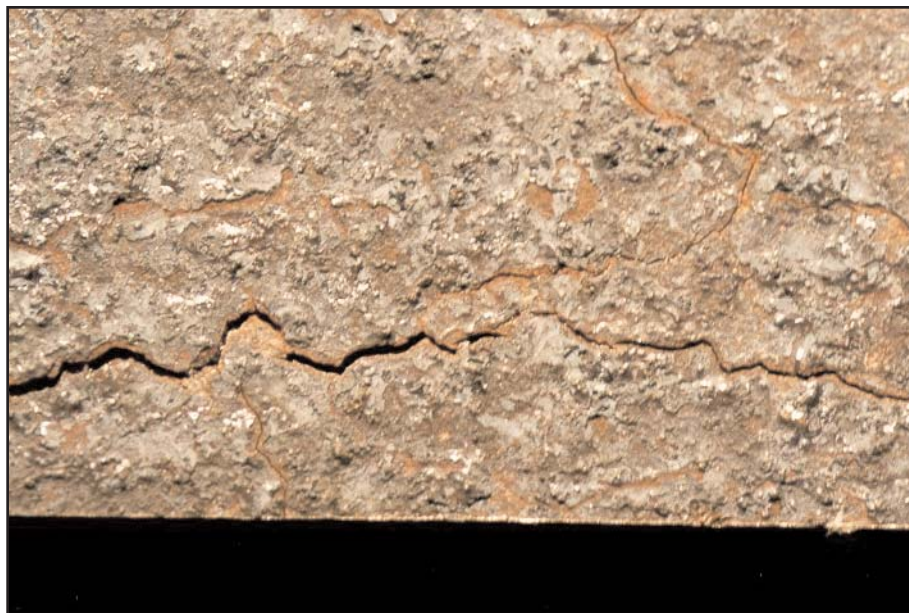
Numerous fissures and cracks formed in the dome of the degasifier section of a deaerator, requiring replacement of the entire dome (Figure IX-14). The system was shut down for four weeks before failure, during which time the deaerator was kept hot with steam feed. No failures occurred when the unit was restarted. However, after four days of operation several cracks penetrated through the dome. The internal surface was also covered with substantial amounts of iron oxide corrosion products that formed in place. These corrosion products overlaid shallow depressions (Figure IX-15).

Figure IX-14: Cracks on Internal Surface Covered with Iron Oxide Corrosion Products
